**Approach above glide path, interception of ILS sidelobe signal,  
increase in pitch angle commanded by autopilot**

<b>Aircraft</b>	Airbus A340-300 registered F-GLZU
<b>Date and time</b>	13 March 2012 at 04 h 50 <sup>(1)</sup>
<b>Operator</b>	Air France
<b>Place</b>	On approach to Paris Charles de Gaulle Airport (95)
<b>Type of flight</b>	International public transport of passengers
<b>Persons on board</b>	Captain (PF) Co-pilot (PNF)
<b>Consequences and damage</b>	None

*This is a courtesy translation by the BEA of the Final Report on the Safety Investigation. As accurate as the translation may be, the original text in French is the work or reference.*

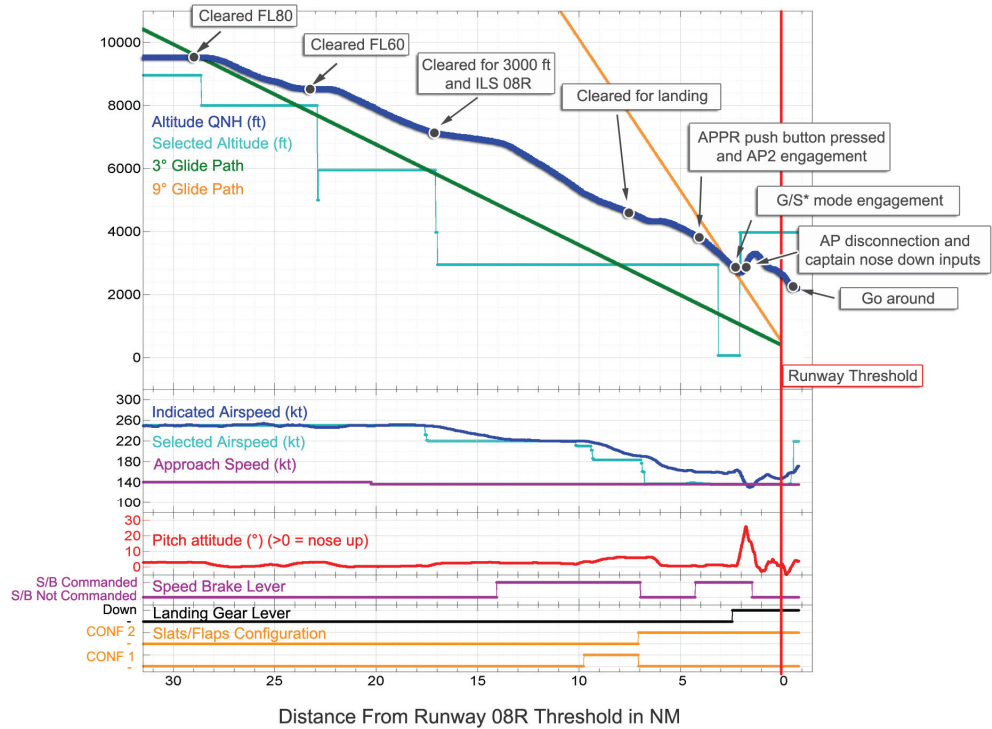
Figure 1: Vertical flight path of F-GLZU

The crew selected slats/flaps configuration 2 and retracted the airbrakes. About one minute later, they re-extended the airbrakes, set the G/S mode using the APPR switch and engaged autopilot 2. The glide deviation displayed on the PFD indicated to the crew that they were approaching the glide path from above. The aeroplane was 4 NM from the runway threshold, at about 3,700 ft (that is 2,100 ft above the glide path at 3°) and was located in an ILS signal sidelobe.

About 30 seconds later, the crew extended the landing gear. The glide path capture mode (G/S\*) was activated when the aeroplane was 2 NM from the runway threshold at 2,850 ft (that is about 1,600 ft above the glide path at 3°). The ATHR changed to SPEED mode. The pitch attitude increased from 1° to 26° in 12 seconds. The PNF stated that he had called out the difference in the pitch attitude when the chevrons<sup>(4)</sup> appeared. When the aeroplane pitched up, the speed dropped from 163 kt to 130 kt, the vertical speed changed from -1,600 ft/min to +3,300 ft/min. When the pitch attitude reached 26°, the crew disconnected both autopilots and the PF made a pitch down input almost down to the stop. The pitch attitude and vertical speed decreased. The crew retracted the airbrakes. The throttle levers were in the IDLE position. The speed was 143 kt and the ATHR disengaged. About 30 seconds later, autopilot 1 was engaged, the levers were repositioned on the CL setting and the ATHR was activated. The PF explained that he engaged autopilot 1 to perform a go-around on automatic<sup>(5)</sup>. The LOC and G/S modes were active and the ATHR was in SPEED mode. The speed was 147 kt. The aeroplane was directly above the runway threshold at an altitude of about 2,700 ft. The pitch attitude then decreased from 2° to -5° and the aeroplane descended.

The PF stated that he realised that the modes displayed on the FMA were not appropriate. He then disengaged the AP 8 seconds after having activated it and then displayed a pitch attitude of about 6° and placed the throttle levers in the TOGA setting at an altitude of about 2,000 ft.

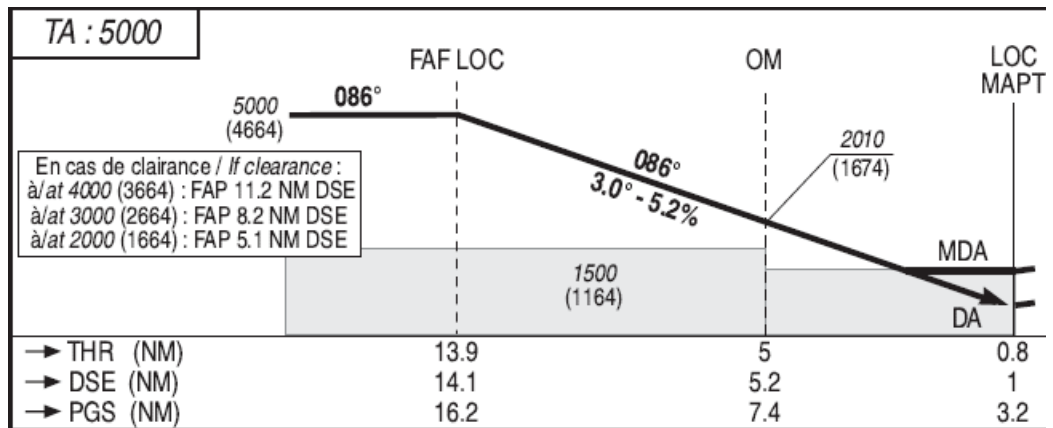
Figure 2: Extract from the AIP approach chart

The ILS CATIII RWY 08R AIP approach chart for 8 March 2012 defined the FAP position according to the clearance altitude given by the controller in the following way:

- At 5,000 ft, the FAP is about 14 NM from the runway threshold;
- At 4,000 ft, the FAP is about 11 NM from the runway threshold;
- At 3,000 ft, the FAP is about 8 NM from the runway threshold;
- At 2,000 ft, the FAP is about 5 NM from the runway threshold.

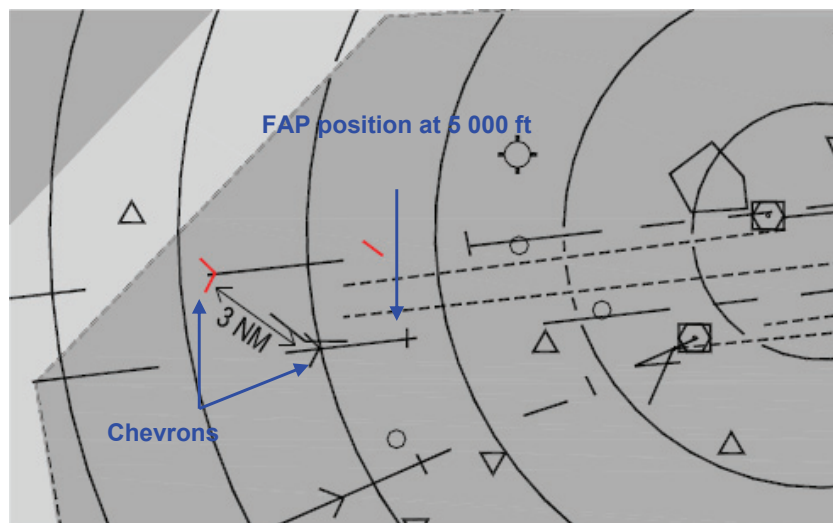
Figure 3: Visual reference points on the radar screen

The visual reference points are to allow levelling off before final descent (standard approach) and to ensure aircraft separation in the event of simultaneous approaches.

Those on the screen for runway 08R correspond to the position of the FAP at an altitude of 5,000 ft.

During this incident, the controller forgot to request the crew to descend. When he realised this, the aeroplane could no longer follow the published trajectory with an FAP at an altitude of 5,000 ft. The controller could not therefore use the only reference points available on his screen to check the flight path.

- **DGAC study the implementation of a system enabling controllers to determine the vertical position of an aircraft in relation to the published glide path. [Recommendation FRAN-2013-007]**

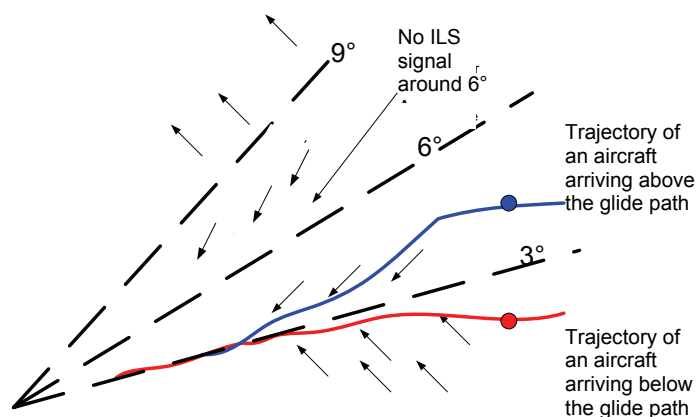
Figure 4: Direction of the ILS signal deviation

The simplified principle of the deviation direction of the glide path signal is described by the diagram below: the main lobe at  $3^\circ$  forms the published glide path and a sidelobe is present at about  $9^\circ$ . In this sidelobe, the signs of deviation are inverted by design.

The parameters recorded by the aeroplane made it possible to determine that the ILS 08R sidelobe slope was close to  $10^\circ$  on the day of the incident.

During this incident, in autopilot, the G/S\* mode was engaged on an ILS signal of a sidelobe defining a descent slope of about  $10^\circ$ . The autopilot interpretation of the ILS signal led to an increase in pitch. This pitch up increase continued until it reached  $26^\circ$ . The crew then disconnected the autopilot and performed a missed landing.

The aeroplane entered a sidelobe beam at 10°. The glide path indication strengthened the crew's conviction that they were getting closer to the path at 3° from above whereas in reality they were getting closer to the path at 10° from below. The crew set up the G/S mode while the aeroplane was beyond the FAP, 2,100 ft above the path and 4 NM from the threshold.

- **EASA ensure that aircraft ILS modes are not engaged on an ILS signal other than the one corresponding to the published descent path; that failing this, a system enabling the crew to be alerted be put in place; [Recommendation FRAN-2013-008]**

- **EASA ensure that the activation of aircraft ILS modes in autopilot does not lead to inappropriate attitudes during approach. [Recommendation FRAN-2013-009]**
